QUAD

**electrostatic
loudspeaker
service supplement**

SERVICING QUAD ELECTROSTATIC LOUDSPEAKERS

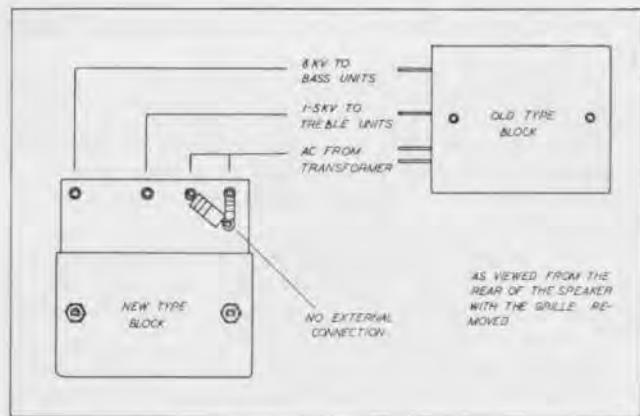
To replace the rectifier block of the EHT unit, undo the two 4BA nuts securing it to the framework of the EHT unit and remove it. If the replacement block is found to be of a different type it will still be electrically and physically interchangeable with the earlier type, and the equivalent connections are shown in Fig. 1. If the leads to the loudspeaker units have to be extended, the joints should be insulated with high voltage sleeving and staggered so that two joints do not lie together.

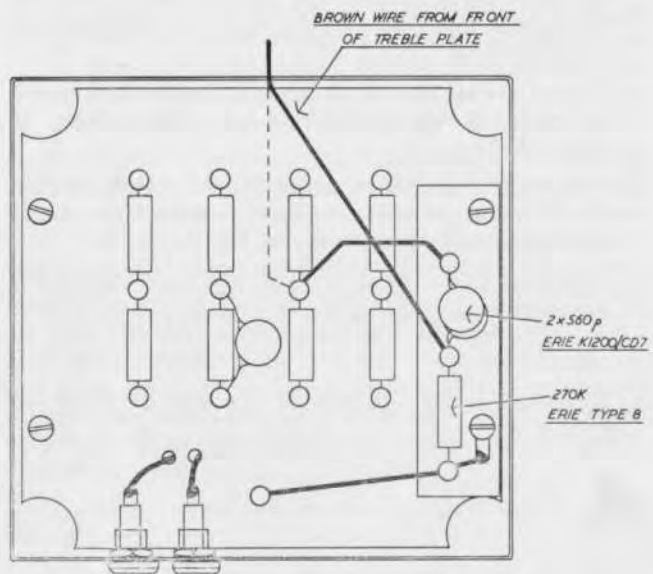
The components required can be obtained ready assembled on a tagboard, if required, and Fig. 2 shows this in position under the audio transformer. Alternatively, suitable resistors and capacitors from normal servicing stocks, may be used if preferred.

4. Remove the four screws holding the audio transformer (large can on the lefthand side) in place, remembering to support the transformer before it is freed or it may slip and damage the lefthand bass unit dustcover.
5. Restore the speaker to an upright position and invert the audio transformer, taking care not to strain its external wiring.
6. Remove the two drive screws on the righthand side of the tagboard and use these to secure the small tagboard supplied, as shown in Fig. 2.
7. Rewire as shown, ensuring that the brown lead which has to be stretched to reach its new anchor point does not press against any sharp edges of turret lugs or solder.
8. Re-assemble the speaker in the reverse order of operations 1 to 5.

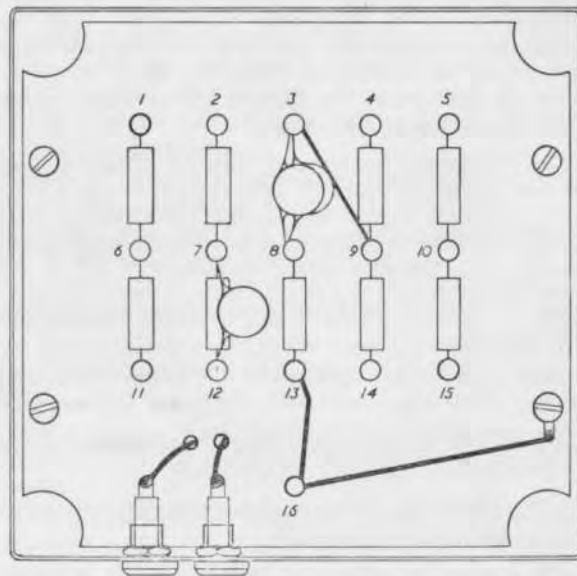
Fig. 3 shows the tagboard layout from serial number 16800 onwards.
